**Flood Control Project Maintenance
Levee Inspections****LMA District Cover Sheet****Spring 2011 Levee Inspection Results****Sacramento Maintenance Yard West Levee Yolo Bypass**

Levee Inspection Report By Mile - Spring 2011

Sacramento Maintenance Yard West Levee Yolo Bypass

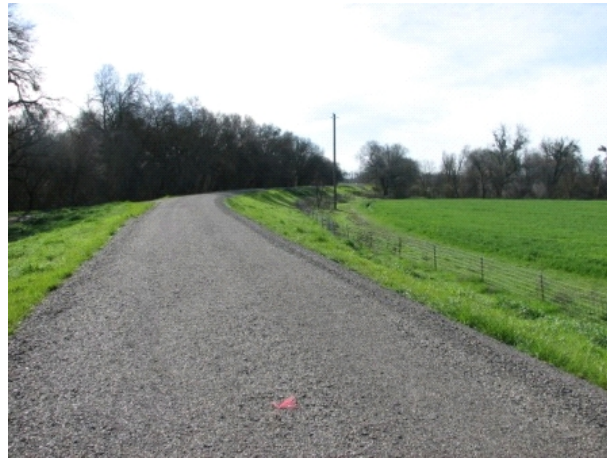
Levee Mile Report Line	1
Start Levee Mile	0.18
End Levee Mile	0.18
Location	Water Side
Category	Earthen Levee
Item	Vegetation

This is a view of the grasses they are acceptable.
3-7-1. The view is of both sides of the levee slope.

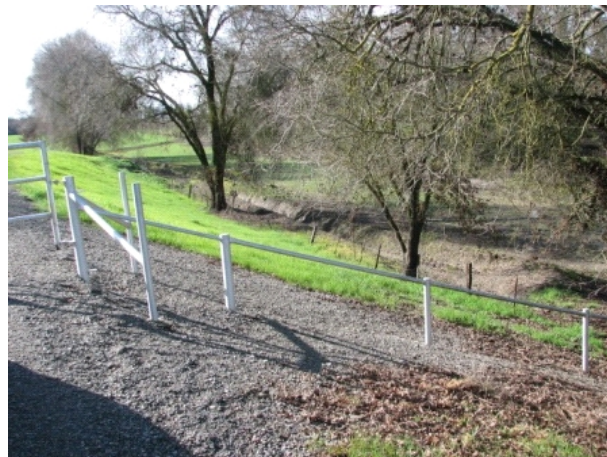
Levee Mile Report Line	3
Start Levee Mile	0.36
End Levee Mile	0.43
Location	Land Side
Category	Earthen Levee
Item	Encroachments

3-7-11 Aricultural ditch running along toe of
landside

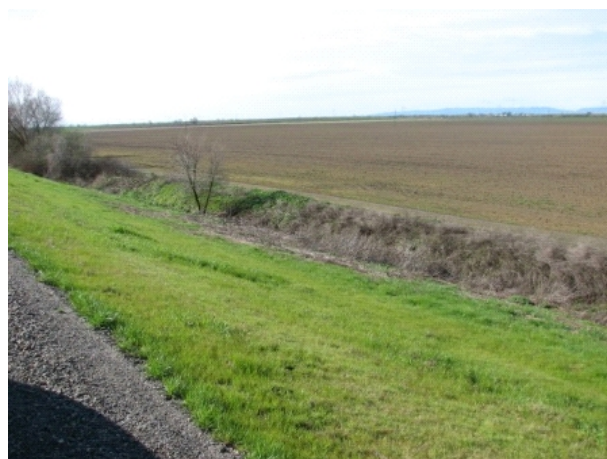
Levee Mile Report Line	4
Start Levee Mile	0.93
End Levee Mile	1.63
Location	Land Side
Category	Earthen Levee
Item	Encroachments

3-7-11 Agricultural ditch running along toe
landside.

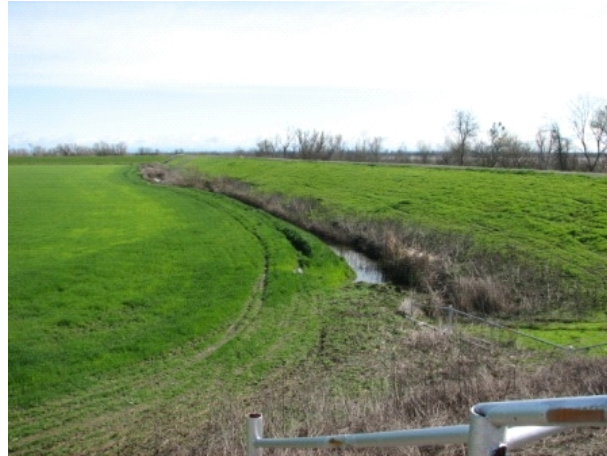
Levee Mile Report Line	6
Start Levee Mile	2.63
End Levee Mile	2.70
Location	Land Side
Category	Earthen Levee
Item	Encroachments
Agricultural ditch running along toe landside. 3-7-11	
johngw_s_20110307_335.jpg

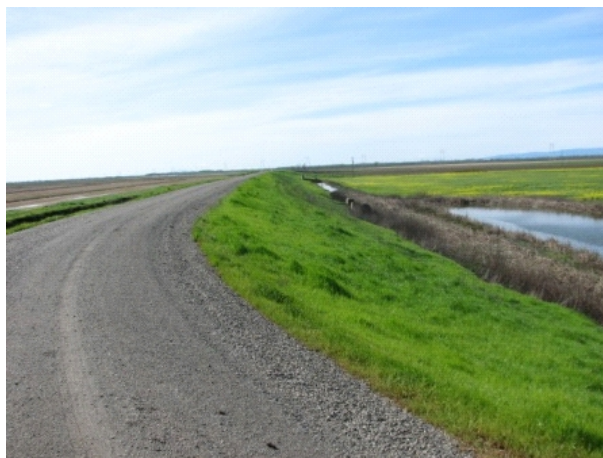
Levee Mile Report Line	2
Start Levee Mile	0.00
End Levee Mile	0.00
Location	Land Side
Category	Earthen Levee
Item	Vegetation

3-7-11 Good maintenance of grasses on both sides of levee.

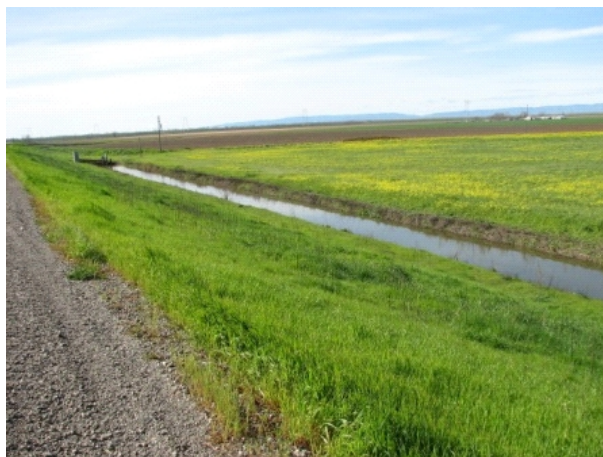
Levee Mile Report Line	3
Start Levee Mile	0.08
End Levee Mile	0.21
Location	Land Side
Category	Earthen Levee
Item	Encroachments

Agricultural ditch running along toe 3-7-11

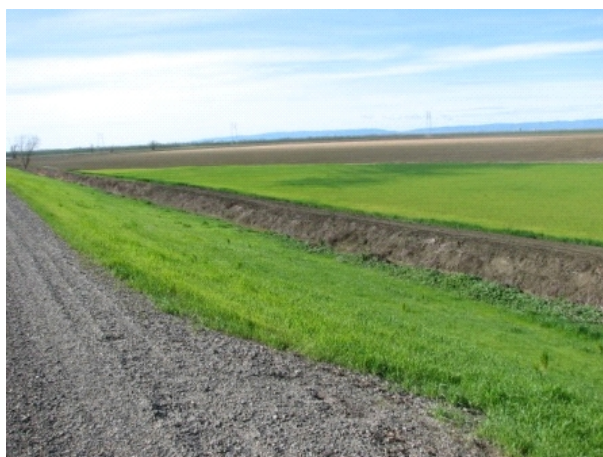
Levee Mile Report Line	4
Start Levee Mile	0.47
End Levee Mile	0.97
Location	Land Side
Category	Earthen Levee
Item	Encroachments

Agricultural ditch running along toe of levee. 3-7-11

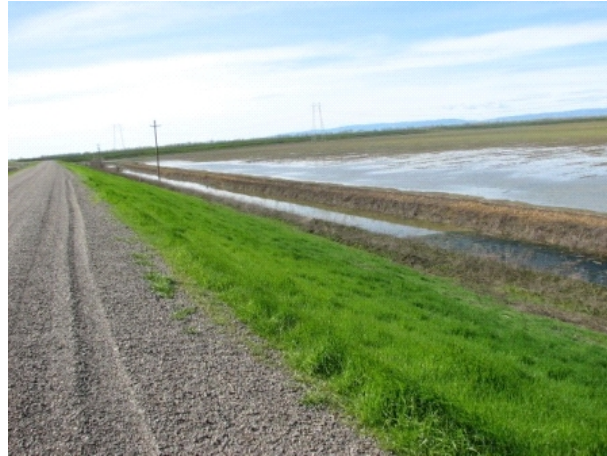
Levee Mile Report Line	5
Start Levee Mile	1.15
End Levee Mile	1.44
Location	Land Side
Category	Earthen Levee
Item	Encroachments
Agricultural ditch running along toe of levee. 3-7-11	
johngw_s_20110307_339.jpg

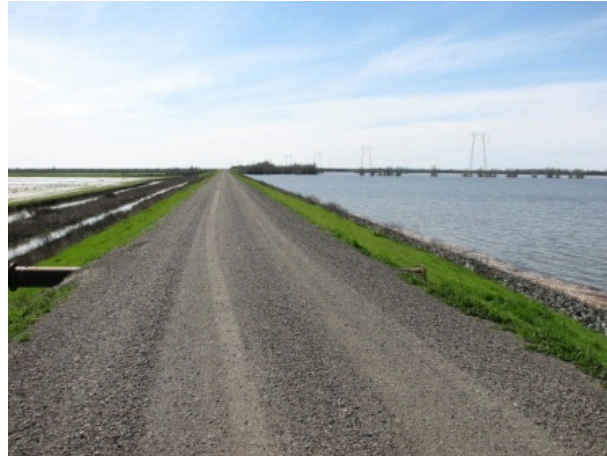
Levee Mile Report Line	1
Start Levee Mile	0.01
End Levee Mile	0.01
Location	Water Side
Category	Earthen Levee
Item	Vegetation

The grasses are acceptable on both sides of the levee. 3-7-11. The view is of both sides of the levee slope.

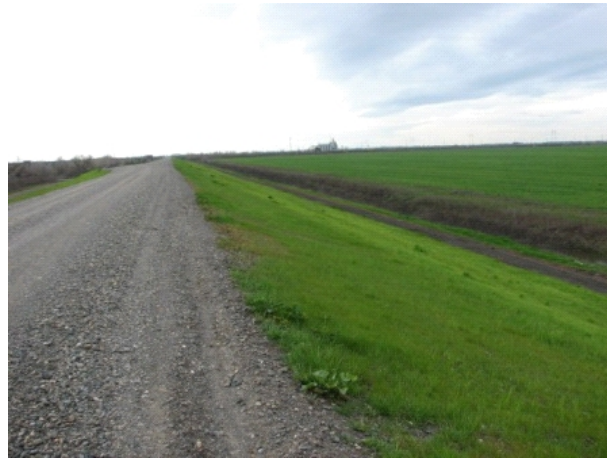
Levee Mile Report Line	1
Start Levee Mile	0.03
End Levee Mile	0.03
Location	Land Side
Category	Earthen Levee
Item	Vegetation

The view of the landside grasses that do not exceed 12".

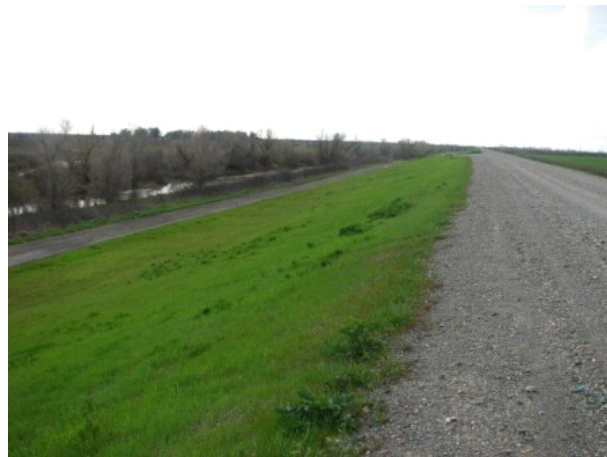
Levee Mile Report Line	2
Start Levee Mile	0.03
End Levee Mile	0.03
Location	Water Side
Category	Earthen Levee
Item	Vegetation

This view is the waterside grasses that do not exceed 12".

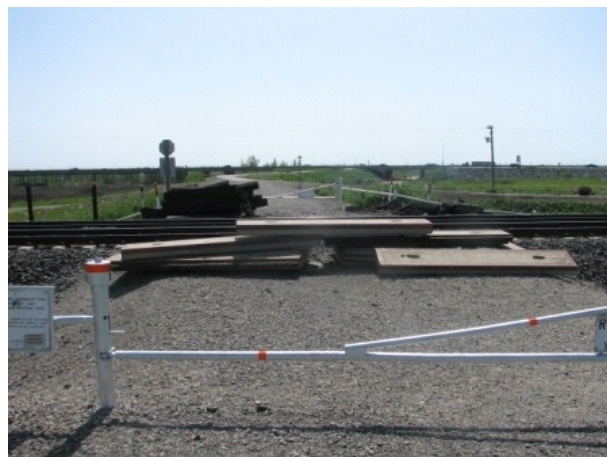
Levee Mile Report Line	3
Start Levee Mile	0.57
End Levee Mile	0.57
Location	Crown
Category	Earthen Levee
Item	Encroachments

changing railroad ties out; crown blocked

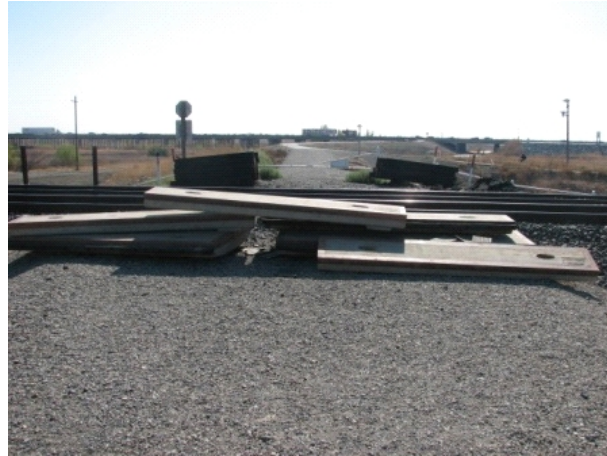
Levee Mile Report Line	3
Start Levee Mile	0.57
End Levee Mile	0.57
Location	Crown
Category	Earthen Levee
Item	Encroachments

This photo was taken 10/19/10, levee is still blocked.

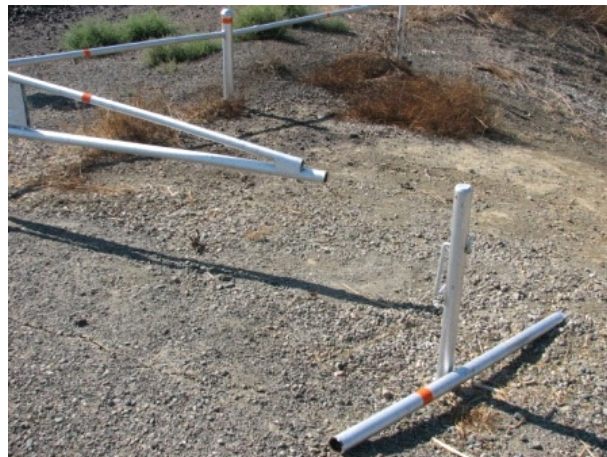
Levee Mile Report Line	3
Start Levee Mile	0.57
End Levee Mile	0.57
Location	Crown
Category	Earthen Levee
Item	Encroachments

The gate at the railroad tracks has been cut. Need to remove railroad ties and repair gate.

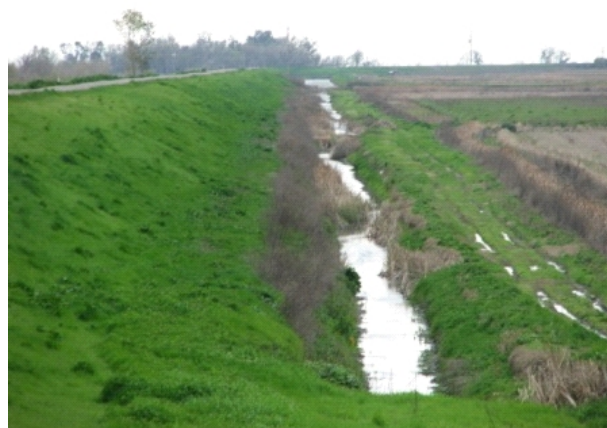
Levee Mile Report Line	4
Start Levee Mile	1.78
End Levee Mile	2.70
Location	Land Side
Category	Earthen Levee
Item	Encroachments

The agricultural ditch runs along the landside toe.

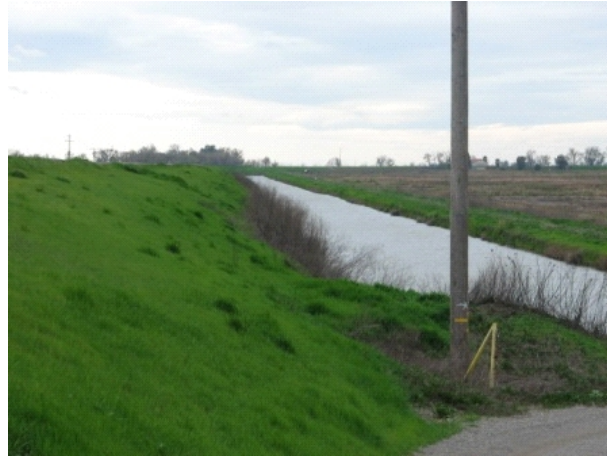
Levee Mile Report Line	5
Start Levee Mile	2.76
End Levee Mile	3.60
Location	Land Side
Category	Earthen Levee
Item	Encroachments

The agricultural ditch runs along the toe of the landside.

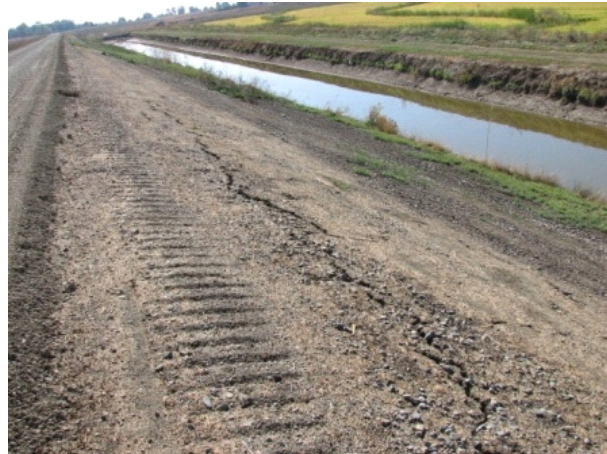
Levee Mile Report Line	6
Start Levee Mile	3.36
End Levee Mile	3.43
Location	Land Side
Category	Earthen Levee
Item	Cracking

4	1.78	2.70	Earthen Levee	Encroachments	LS	PO	Agricultural Ditch	38.550387 ° -121.631257 °	38.536958 ° -121.631450 °	3 Y
5	2.76	3.60	Earthen Levee	Encroachments	LS	PO	Agricultural Ditch	38.536100 ° -121.631425 °	38.523807 ° -121.631535 °	4 Y
6	3.36	3.43	Earthen Levee	Cracking	LS	A	Monitor and have inspected by geotechnical engineer. Inspector Comments: I viewed the cracks while driving back to hwy. There is cracking along the length of the entire ag. ditch. (3-10-2011)The cracks have closed due to winter moisture. The cracks may return during the summer and fall months.	38.527302 ° -121.631455 °	38.525952 ° -121.631467 °	1 Y

There are cracks running along the landside shoulder. They run off and on the distance of the ditch.
